Manhole Inspection Summary

Manhole # S21M__015MH

Insp Date: **2/24/09 10:34 AM**

Location Address: **1850 EAGLE ST**

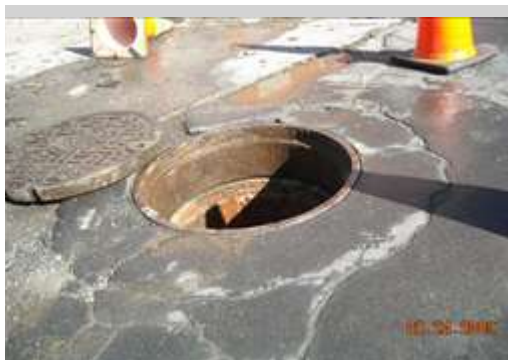
MISC.

POST CLEANING

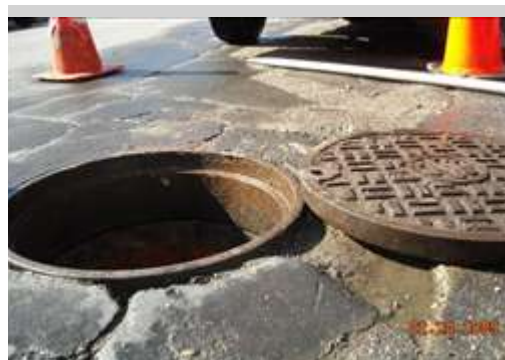
MISC.

Comments **HEAVY CLEANING FROM DOWN STREAM MANHOLE S21M__022MH TO REMOVE
GREASE DEPOSITS AND ALEAVIATE SURCHARGE; ASPHALT IS SETTLED AND
CRACKED AROUND FRAME**

ASPHALT CRACKED IN SHAPE OF FRAME

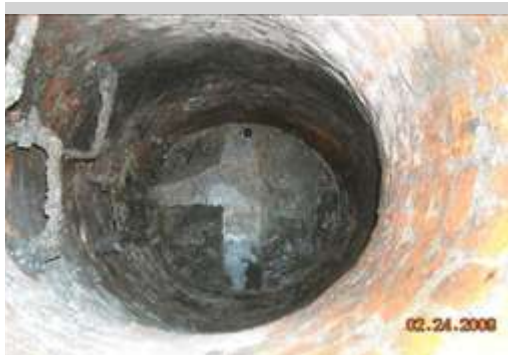
MISC.

Manhole Type: **Junction** Location: **Roadway** Ground Conditions: **Dry**
☐ Prev. Rehab Weather: **Dry** Subject To Ponding: **Sheeting**

EVIDENCE OF SHEETING

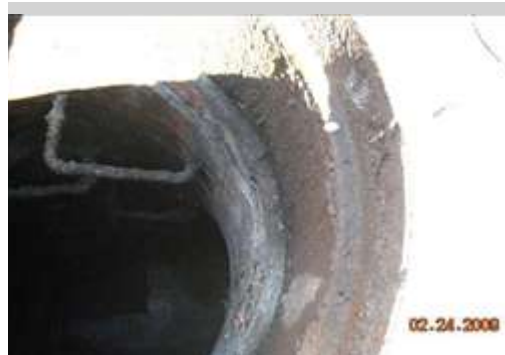
Defect 2

TOP VIEW PRIOR TO CLEANING

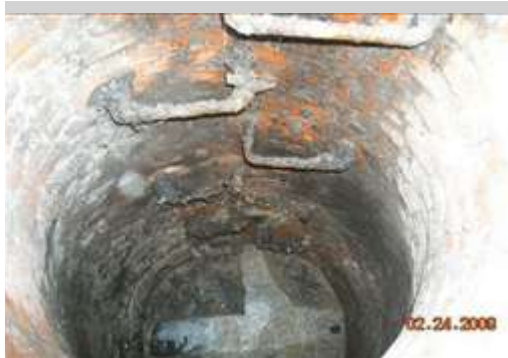
Defect 1

Frame Offset: **0.5** (in.) Condition: ☒ Sound ☐ Cracked ☐ Leaks

FRAME OFFSET

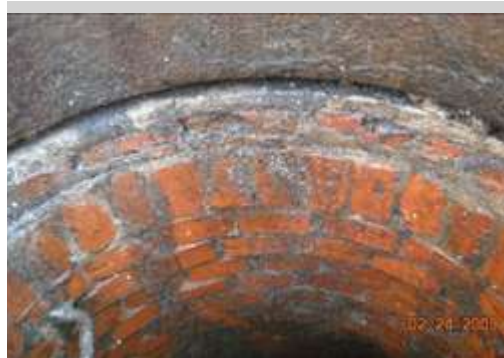
Defect 5

Steps Count: **6** Missing: **2** ☒ **Corroded**

CORRODED AND MISSING STEPS

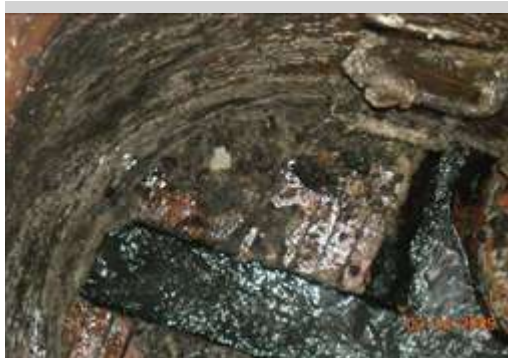
Defect 4

Chimney / Frame Adjustment ☒ Exists Material: **Brick** ☐ Parged Height: **5** (in.)
Condition: ☒ Sound ☐ Cracked ☐ Root Intrusion ☐ Loose Brick ☐ Deteriorated
Infiltration: ☐ None ☒ **Joint** ☐ Cracks ☐ Mortar ☐ Roots ☐ Wall

INFILTRATION @ CHIMNEY FRAME JOINT

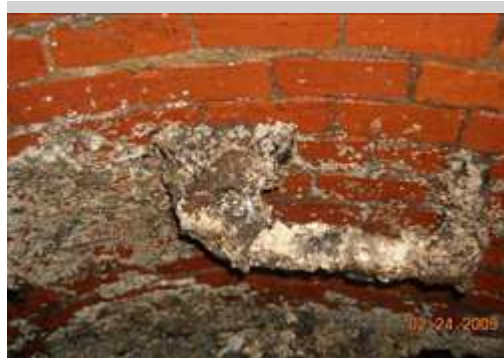
Defect 3

Bench ☒ Exists Material: **Brick** ☐ Parged
Condition: ☐ Sound ☐ Cracked ☐ Root Intrusion ☐ Deteriorated ☐ Leaks ☒ **Debris**

DEBRIS ON BENCH

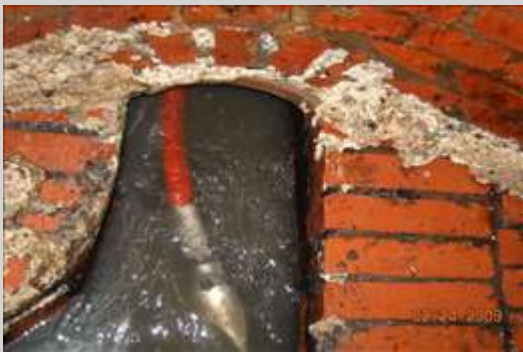
12 O'Clock Outflow

Pipe Height: **10.8** (in.) Rod and Bar (Angled)
Pipe Material: **Clay** ☐ Pipe Lined
Invert Depth: **12.30** (ft.) Flow Characteristics: **Fast**
Deposits: ☒ None ☐ Mud ☐ Sludge ☐ Debris ☐ Grease
Silt Depth: **0** (in.) Deposits Extent:
Infiltration: **None** Pipe Seal Cond: **Sound**

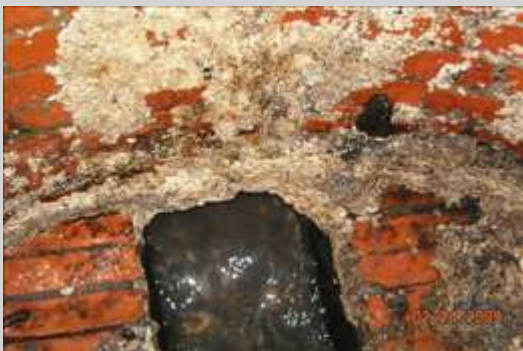
6 O'Clock Inflow

Pipe Height: **10.8** (in.) Rod and Bar (Angled)
Pipe Material: **Clay** ☐ Pipe Lined
Invert Depth: **12.25** (ft.) Flow Characteristics: **Fast**
Deposits: ☒ None ☐ Mud ☐ Sludge ☐ Debris ☐ Grease
Silt Depth: **0** (in.) Deposits Extent:
Infiltration: **None** Pipe Seal Cond: **Unknown**

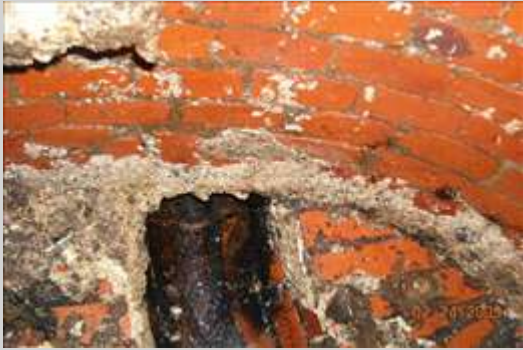
9 O'Clock Inflow

Deposits: ☐ None ☐ Mud ☐ Sludge ☐ Debris ☒ **Grease**

Silt Depth: **1** (in.) Deposits Extent: **Light**
